**Flood Control Project Maintenance
Levee Inspections**
LMA District Cover Sheet
Spring 2019 Levee Inspection Results

Reclamation District No. 2064 River Junction

Spring 2019 Levee Inspection Results

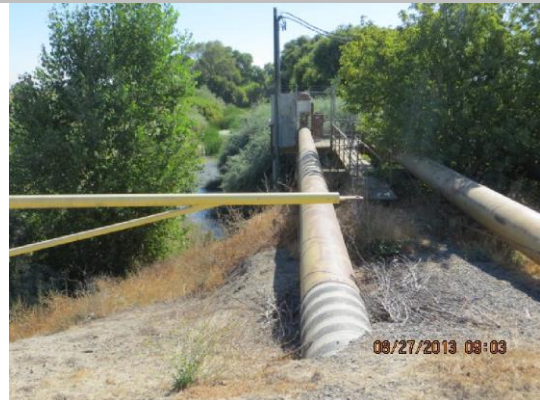
Photo 1 of 3 : UCIP_SP_2019_18718_31286.jpg

LM Start	0.06	Rating **	M	Issue No.	37
LM End	0.06	Issue Type +	En	Location *	
Category	Supplemental			GPS Latitude/Longitude	
				Start	End
Item	DWR UCIP Field Study			37.709725 °	37.709725 °
				-121.267534 °	-121.267534 °
DWR ID	20512				
Comment Code					
Inspector Comment					
FS_ID:18718 DS_ID:20512 EP_NO: 13907 Repair Type: Non-Urgent Crossing Status: Found UCIP Comments: This pipe has less than 1-foot of cover. FIELD_STRUCT_DESC: 1 of 3: 24-inch coated steel drainage discharge pipe through the levee, 2 feet below the crown. Two 100- horsepower and one 75-horsepower pumps on the landside (LS) toe. Siphon breaker on the waterside (WS) shoulder. (Permit No. 13907, 1985 - Reclamation District No. 2064). [Additional Reference(s): DWR Levee Log, 2005]. FS Date: 8/27/2013

Steel storm drain pipe with pump on pier in background.

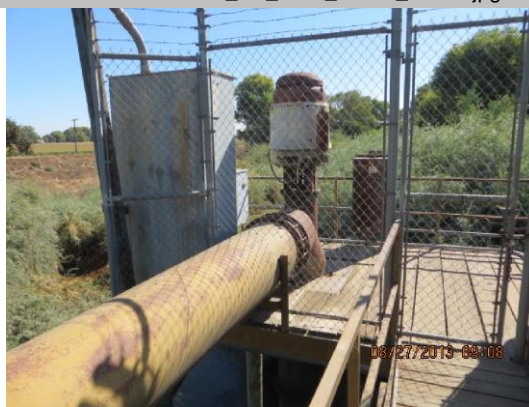
Photo 3 of 3 : UCIP_SP_2019_18718_31284.jpg

Pump on wooden pier on LS toe.

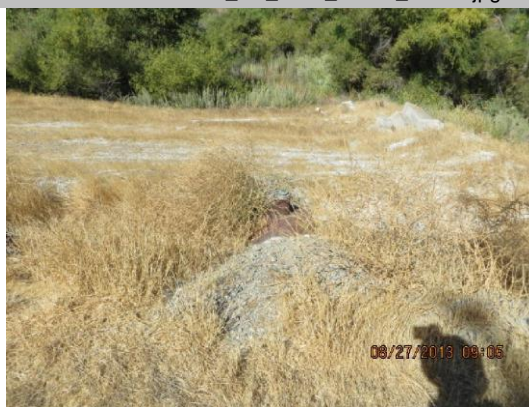
Photo 2 of 3 : UCIP_SP_2019_22729_38457.jpg

LM Start	0.06	Rating **	M	Issue No.	38
LM End	0.06	Issue Type +	En	Location *	
Category	Supplemental			GPS Latitude/Longitude	
				Start	End
Item	DWR UCIP Field Study			37.709698 °	37.709698 °
				-121.267536 °	-121.267536 °
DWR ID	20527				
Comment Code					
Inspector Comment					
FS_ID:22729 DS_ID:20527 EP_NO: 13907 Repair Type: Non-Urgent Crossing Status: Found UCIP Comments: This pipe has less than 1-foot of cover. FIELD_STRUCT_DESC: 2 of 3: 24-inch coated steel drainage discharge pipe through the levee, 2 feet below the crown. Two 100-horsepower and one 75-horsepower pumps on pier at the landside (LS) toe. Siphon breaker on the waterside (WS) shoulder. (Permit No. 13907, 1985 - Reclamation District No. 2064). [Additional Reference(s): DWR Levee Log, 2005]. FS Date: 8/27/2013

Pipe and siphon breaker on WS shoulder.

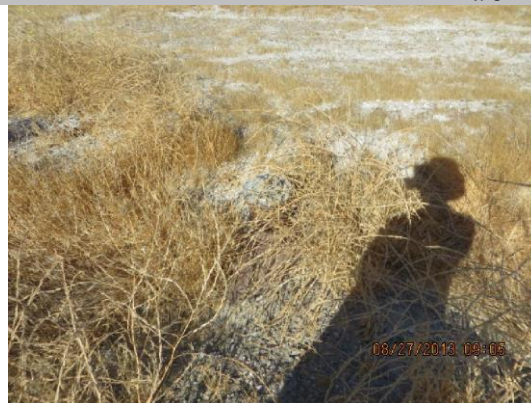
Photo 2 of 3 : UCIP_SP_2019_18720_31293.jpg

LM Start	0.06	Rating **	M	Issue No.	39 (cont)
LM End	0.06	Issue Type +	En	Location *	
Category	Supplemental			GPS Latitude/Longitude	
				Start	End
Item	DWR UCIP Field Study			37.709672 °	37.709672 °
				-121.267532 °	-121.267532 °
DWR ID	20528				
Comment Code					
Inspector Comment					
FS_ID:18720					
DS_ID:20528					
EP_NO: 13907					
Repair Type: Non-Urgent					
Crossing Status: Found					
UCIP Comments: This pipe has less than 1-foot of cover.					
FIELD_STRUCT_DESC: 3 of 3: 24-inch coated steel drainage discharge pipe through the levee, 1 foot below the crown. Two 100-horsepower and one 75-horsepower pumps on the landside (LS) toe. Siphon breaker on the waterside (WS) shoulder. (Permit No. 13907, 1985 - Reclamation District No. 2064). [Additional Reference(s): DWR Levee Log, 2005].					
FS Date: 8/27/2013

Siphon breaker visible on WS shoulder.

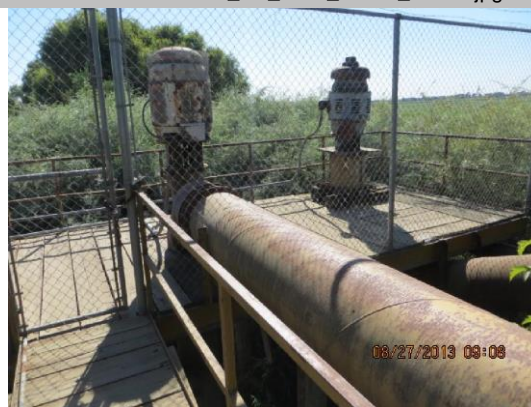
Photo 3 of 3 : UCIP_SP_2019_18720_31292.jpg

Pump on pier on LS.

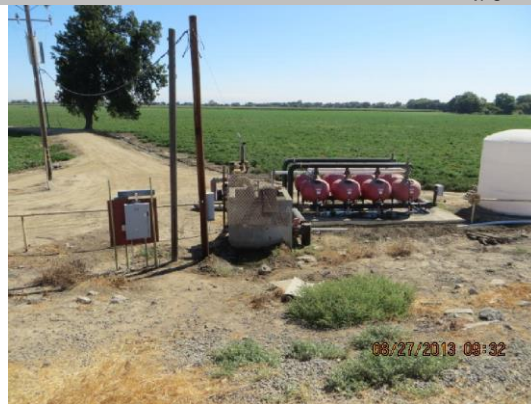
Photo 2 of 3 : UCIP_SP_2019_40792_31376.jpg

Comment Code					
Inspector Comment					
FS_ID:40792 DS_ID:20533 EP_NO: N/A Repair Type: Non-Urgent Crossing Status: Found UCIP Comments: Pump and slant pipe missing from structure on WS slope. FIELD_STRUCT_DESC: 12-inch concrete encased steel irrigation pipe through the levee, 13 feet below the crown. Slant pump on the waterside (WS) toe. Slide gate in a 36-inch corrugated metal pipe (CMP) riser on the WS shoulder. 6-foot by 6-foot concrete distribution box and filter plant on the landside (LS) toe. 2-inch galvanized iron electrical conduit at the same location. [Additional Reference(s): DWR Levee Log, 2005. USACE San Joaquin O&M Manual 3, December 1968, (HLM 1.24)]. FS Date: 8/27/2013

Concrete distribution box and filter plant on LS toe.

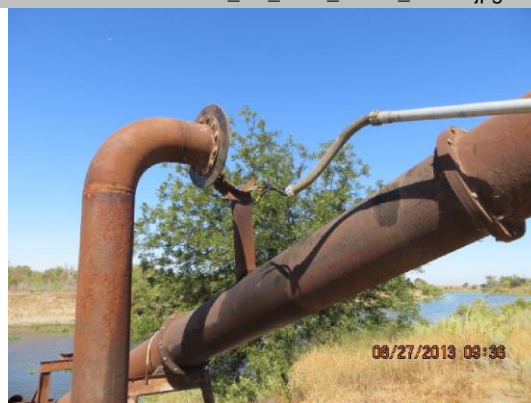
Photo 3 of 3 : UCIP_SP_2019_40792_31375.jpg

Comment Code						
Inspector Comment						
FS_ID:40792						
DS_ID:20533						
EP_NO: N/A						
Repair Type: Non-Urgent						
Crossing Status: Found						
UCIP Comments: Pump and slant pipe missing from structure on WS slope.						
FIELD_STRUCT_DESC: 12-inch concrete encased steel irrigation pipe through the levee, 13 feet below the crown. Slant pump on the waterside (WS) toe. Slide gate in a 36-inch corrugated metal pipe (CMP) riser on the WS shoulder. 6-foot by 6-foot concrete distribution box and filter plant on the landside (LS) toe. 2-inch galvanized iron electrical conduit at the same location. [Additional Reference(s): DWR Levee Log, 2005. USACE San Joaquin O&M Manual 3, December 1968, (HLM 1.24)].						
FS Date: 8/27/2013

Pump and slant pipe missing from structure on WS slope.

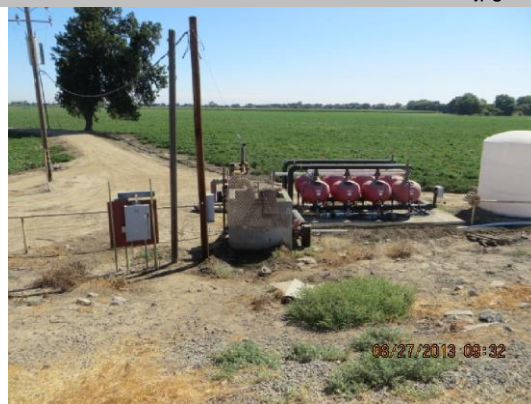
Photo 2 of 3 : UCIP_SP_2019_53378_38461.jpg

FS_ID:53378
DS_ID:20524
EP_NO: 3739
Repair Type: Urgent
Crossing Status: Found
UCIP Comments: 10/10/2018 There is a lot going on at this location; levee erosion and the same sink hole and pipe integrity issue on LS that looks like it has only gotten worse, installation of new steel pipe on WS, and the WS slope looks to have eroded some since the last inspection. Keeping as Urgent, and highly recommend full audit of this crossing, including permitted work and internal pipe inspection (D. Sanoski - DWR UCIP). 11/16/2016 same as last inspection leak has created sink hole near concrete distribution box located on the LS. Hole in pipe is visible at sink hole. Need to contact owner to address leak on LS. Recommend an internal inspection be completed for the pipe through the levee to determine pipe integrity. (O. Magana - DWR UCIP) 08/27/2013 Some leakage at connection between pipe and distro box on LS toe. This may indicate internal failure of pipe. (W. Wylie - DWR UCIP)

Concrete distribution box on LS toe with filter plant.

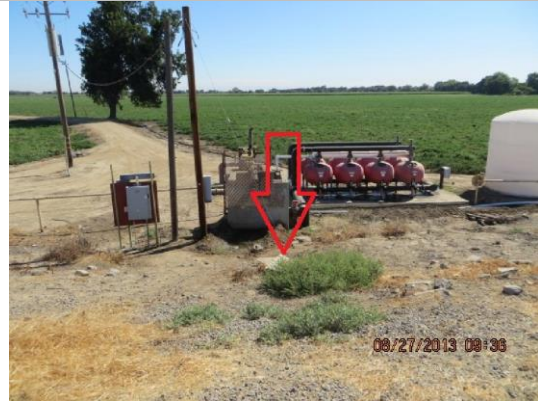
Photo 3 of 3 : UCIP_SP_2019_53378_38460.jpg

Comment Code						
Inspector Comment						
FS_ID:53378 DS_ID:20524 EP_NO: 3739 Repair Type: Urgent Crossing Status: Found UCIP Comments: 10/10/2018 There is a lot going on at this location; levee erosion and the same sink hole and pipe integrity issue on LS that looks like it has only gotten worse, installation of new steel pipe on WS, and the WS slope looks to have eroded some since the last inspection. Keeping as Urgent, and highly recommend full audit of this crossing, including permitted work and internal pipe inspection (D. Sanoski - DWR UCIP).11/16/2016 same as last inspection leak has created sink hole near concrete distribution box located on the LS. Hole in pipe is visible at sink hole. Need to contact owner to address leak on LS. Recommend an internal inspection be completed for the pipe through the levee to determine pipe integrity. (O. Magana - DWR UCIP)08/27/2013 Some leakage at connection between pipe and distro box on LS toe. This may indicate internal failure of pipe. (W. Wylie - DWR UCIP) FIELD_STRUCT_DESC: 16-inch coated steel irrigation pipe through the levee, 10.75 feet below the crown. 2-inch galvanized iron electrical conduit at the same location. Slant pump on the waterside (WS) toe. Slide gate in a 36-inch corrugated metal pipe (CMP) riser on the WS shoulder. 6-foot by 6-foot concrete distribution box and filter plant on the landside (LS) toe. (16-inch pipe authorized under Permit No. 3739, 1961 - Mortensen and Barker). FS Date: 10/10/2018 1:10:00 PM

Leakage along pipe alignment on LS toe.

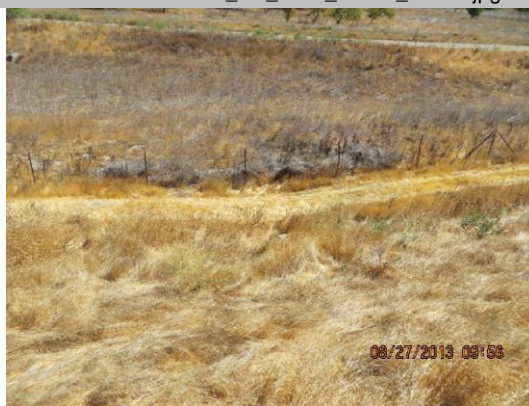
Photo 1 of 3 : UCIP_SP_2019_18748_31380.jpg

LM Start	1.65	Rating **	A/W	Issue No.	42
LM End	1.65	Issue Type +	Ma	Location *	
Category	Supplemental			GPS Latitude/Longitude	
				Start	End
Item	DWR UCIP LMA Responsibility			37.690072 °	37.690072 °
				-121.269823 °	-121.269823 °
DWR ID	20514				
Comment Code					
Inspector Comment					
FS_ID:18748 DS_ID:20514 EP_NO: N/A Repair Type: No Action Needed Crossing Status: Found UCIP Comments: FIELD_STRUCT_DESC: 30-inch by 30-inch reinforced concrete box drainage culvert through the levee, 15 feet below the crown. Slide gate in a concrete riser on the waterside (WS) shoulder. Concrete U-shaped headwalls on both ends. Flap gate on the WS end. [Additional Reference(s): DWR Levee Log, 2005. USACE San Joaquin O&M Manual 3, December 1968, (HLM 1.65)]. FS Date: 8/27/2013

Concrete headwall on LS toe.

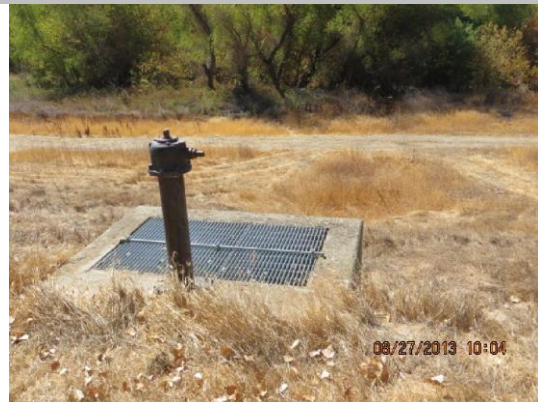
Photo 1 of 3 : UCIP_SP_2019_18763_31402.jpg

LM Start	1.94	Rating **	M	Issue No.	43
LM End	1.94	Issue Type +	Ma	Location *	
Category	Supplemental			GPS Latitude/Longitude	
				Start	End
Item	DWR UCIP LMA Responsibility			37.689900 °	37.689900 °
				-121.264802 °	-121.264802 °
DWR ID	20515				
Comment Code					
Inspector Comment					
FS_ID:18763 DS_ID:20515 EP_NO: N/A Repair Type: Non-Urgent Crossing Status: Found UCIP Comments: Culvert filled nearly to the top with soil. FIELD_STRUCT_DESC: 30-inch by 30-inch reinforced concrete box drainage culvert through the levee, 14.7 feet below the crown. Slide gate in a concrete riser on the waterside (WS) slope. Concrete U-shaped headwalls on both ends. Flap gate on the WS end. [Additional Reference(s): DWR Levee Log, 2005. USACE San Joaquin O&M Manual 3, December 1968, (HLM 1.93)]. FS Date: 8/27/2013

Slide gate in Concrete riser on WS shoulder.

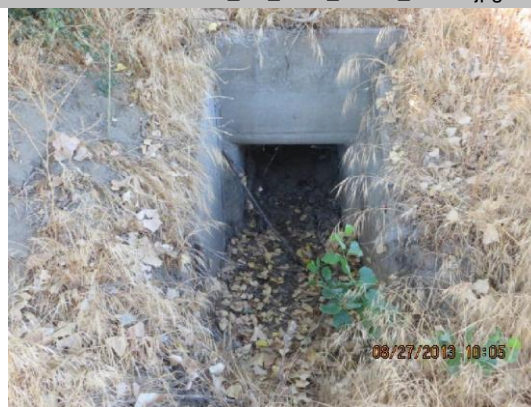
Photo 3 of 3 : UCIP_SP_2019_18763_31400.jpg

Concrete U-shaped headwall on LS toe.

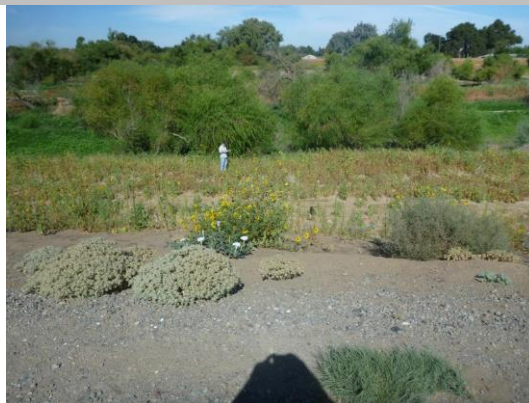
Photo 3 of 3 : SP_2019_RD2064_313_22_20190313_00005.jpg

LM Start	3.26	Rating **	A/W	Issue No.	22 (cont)
LM End	3.39	Issue Type +	Ma	Location *	
Category	Supplemental			GPS Latitude/Longitude	
				Start	End
Item	2017 Storm Damage			37.679100°	37.677800°
				-121.262600°	-121.264400°
DWR ID	DWR_RD2064_01_f_2017_22				
Comment Code					
Inspector Comment					
Levee Evaluation Comments					
Description:Erosion from high water flows caused erosion scarps from 12" to 30" in height. The area of damage is approximately 400 feet in length.					
Site ID No:582					
Site Designation:LMA-488					
Repair Type: Erosion					
Rating:Serious					
Field Date:8/14/2017					
Notes:

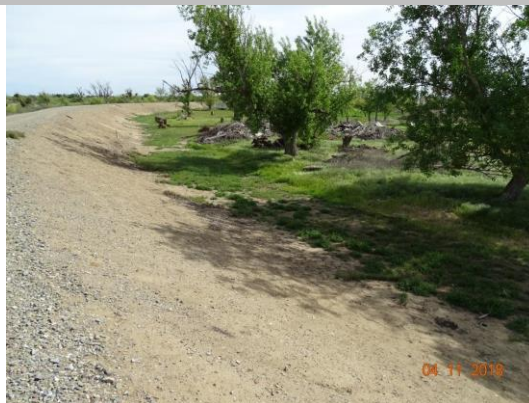
Photo 2 of 2 : SP_2019_RD2064_313_10_20190313_00002.jpg

View of former landside rodent area and slash pile in distance. Fall 2017

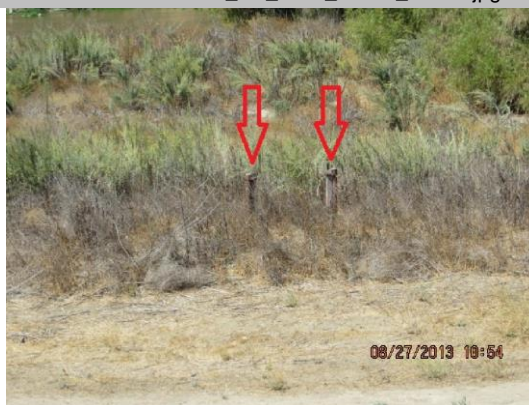
Photo 1 of 1 : UCIP_SP_2019_22731_38463.jpg

LM Start	3.46	Rating **	M	Issue No.	44
LM End	3.46	Issue Type +	En	Location *	
Category	Supplemental			GPS Latitude/Longitude	
				Start	End
Item	DWR UCIP Field Study			37.676751 °	37.676751 °
				-121.264193 °	-121.264193 °
DWR ID	20517				
Comment Code					
Inspector Comment					
FS_ID:22731 DS_ID:20517 EP_NO: N/A Repair Type: Non-Urgent Crossing Status: Indicator Found UCIP Comments: Neet to verify status of pipeline. FIELD_STRUCT_DESC: Underground gas line crossing; depth through the levee and size unknown. Found possible sign posts on WS toe. FS Date: 8/27/2013

Possible sign posts on WS toe.

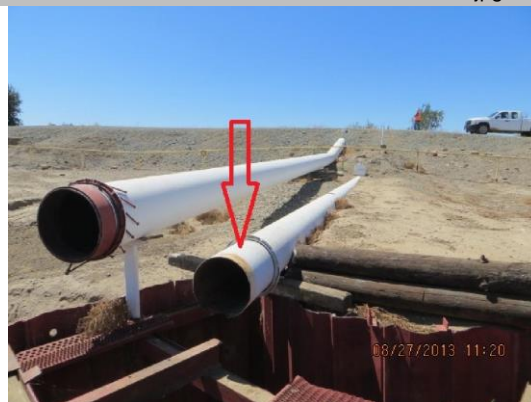
Photo 2 of 3 : UCIP_SP_2019_19044_31843.jpg

Comment Code						
Inspector Comment						
FS_ID:19044						
DS_ID:20519						
EP_NO: 6450						
Repair Type: Non-Urgent						
Crossing Status: Found						
UCIP Comments: Appears abandoned and if so should be done so properly.						
FIELD_STRUCT_DESC: *ABANDONED* 18-inch steel discharge pipe through the levee, 2 feet below the crown. Crown roadway padded over the pipe. Pipe exposed on both slopes. Gate valve on the landside (LS) toe. Pump missing from sump with sheet pile siding in ditch on the LS. Siphon breaker on the waterside (WS). (Permit No. 6450, 1969 - Reclamation District No. 2064). [Additional Reference(s): DWR Levee Log, 2005].						
FS Date: 8/27/2013

Pipe visible at sump off LS toe. No pump or appurtenances.

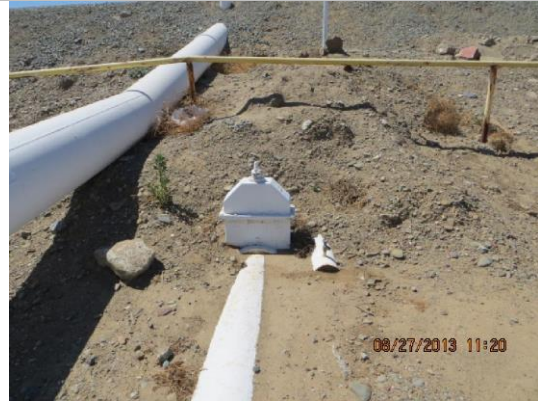
Photo 3 of 3 : UCIP_SP_2019_19044_31842.jpg

Gate valve on LS toe.

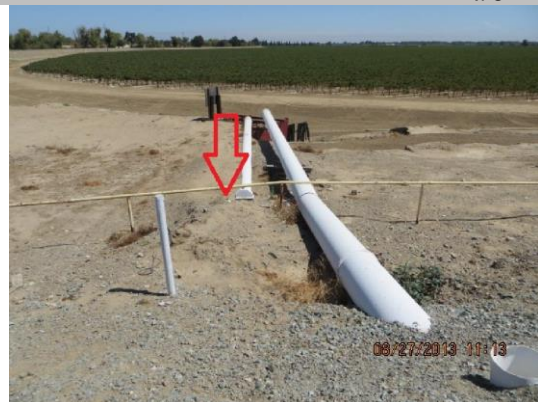
Photo 1 of 2 : UCIP_SP_2019_22732_38465.jpg

Pipe visible on LS toe.

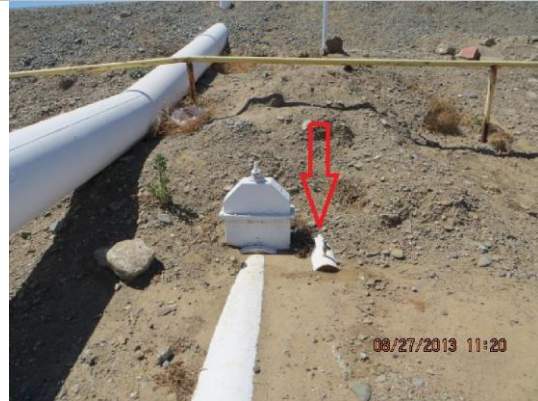
Photo 2 of 2 : UCIP_SP_2019_22732_38464.jpg

Pipe with welded steel plate over LS end at LS toe.

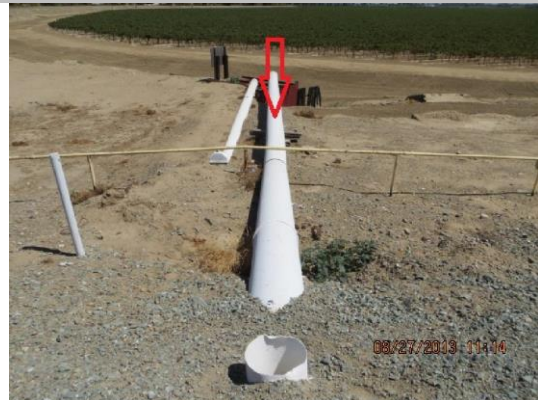
Photo 1 of 3 : UCIP_SP_2019_22733_38468.jpg

Pipe and vent visible on LS slope.

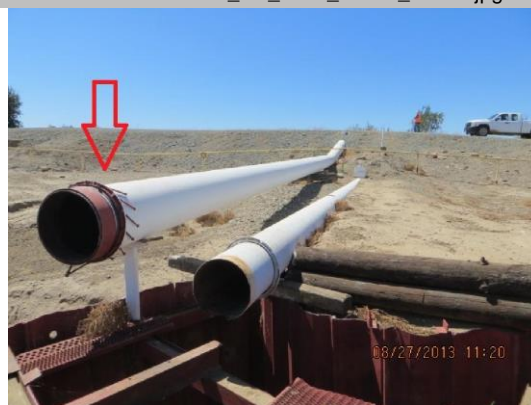
Photo 3 of 3 : UCIP_SP_2019_22733_38466.jpg

Pipe open at pump sump off LS toe.

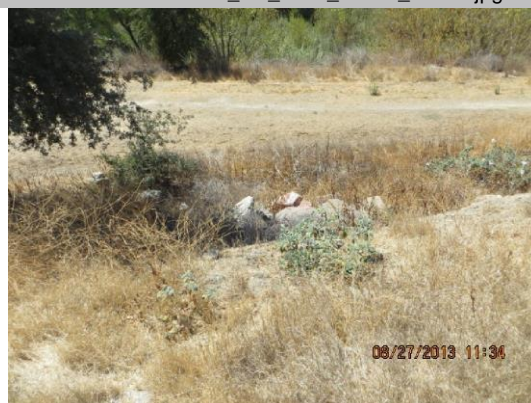
Photo 1 of 2 : UCIP_SP_2019_19046_31849.jpg

Concrete rubble on WS slope possible indicator of abandoned pipe location.

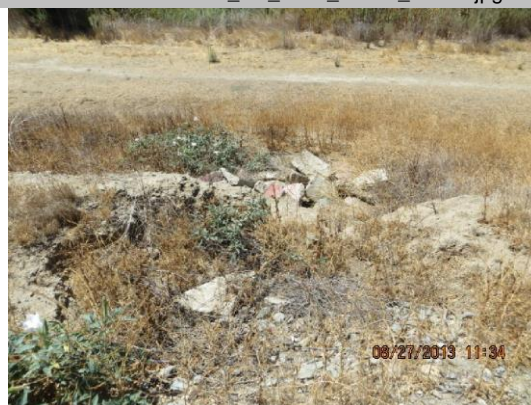
Photo 2 of 2 : UCIP_SP_2019_19046_31848.jpg

Concrete rubble on WS slope possible indicator of abandoned pipe location.

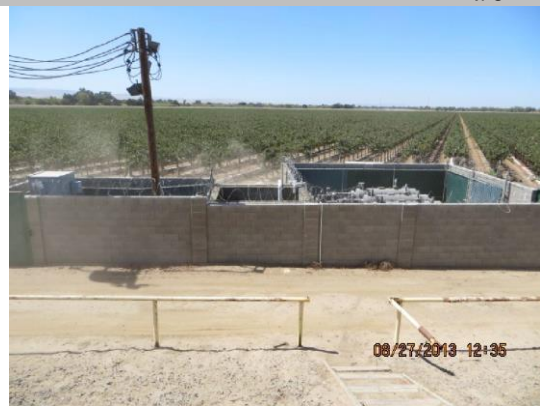
Photo 1 of 2 : UCIP_SP_2019_19063_31861.jpg

Concrete distribution box remains in center of structure on LS toe.

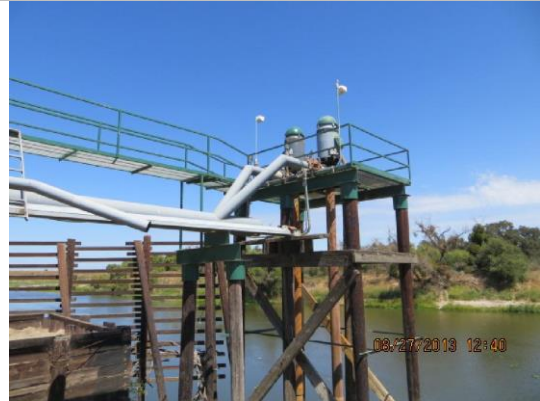
Photo 2 of 2 : UCIP_SP_2019_19063_31860.jpg

Pump platform, walkway, and fender remain in stream. No 24-inch pipe found.

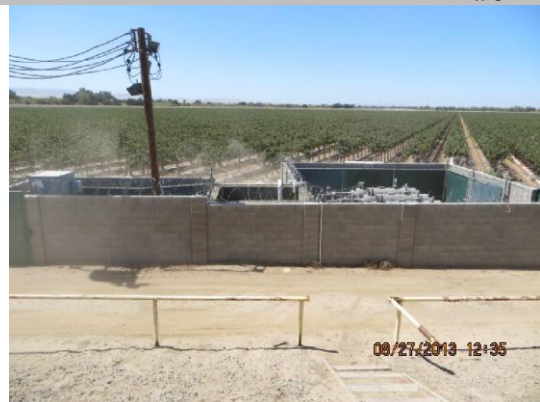
Photo 1 of 2 : UCIP_SP_2019_19064_31863.jpg

Concrete distribution box in center of structure on LS toe.

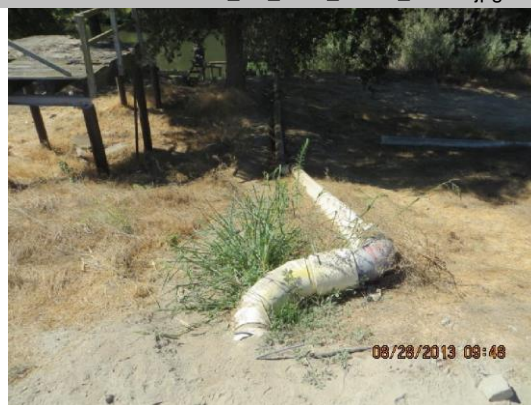
Photo 2 of 3 : UCIP_SP_2019_44653_37714.jpg

Pipe visible on WS shoulder/slope.

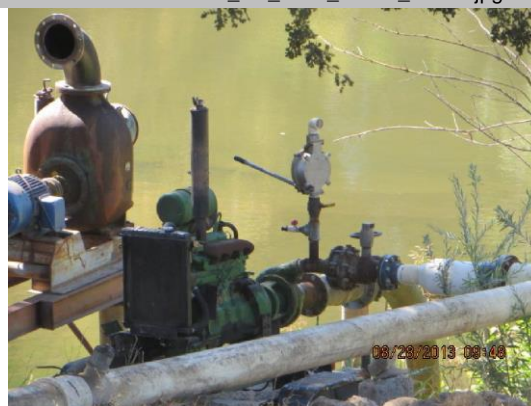
Photo 3 of 3 : UCIP_SP_2019_44653_37713.jpg

Portable pump on WS berm.

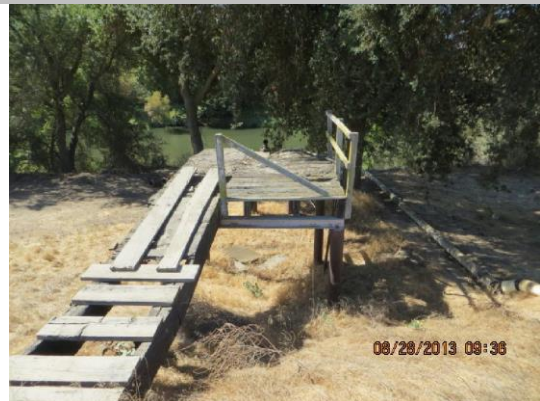
Photo 2 of 3 : UCIP_SP_2019_51385_31891.jpg

Deteriorated wooded pump platform on WS shoulder.

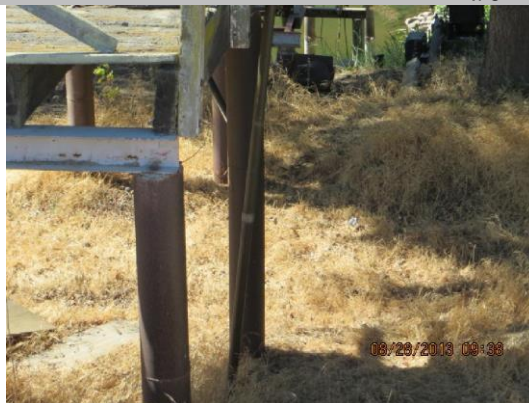
Photo 3 of 3 : UCIP_SP_2019_51385_31890.jpg

2-inch galvanized iron electrical conduit at same location.

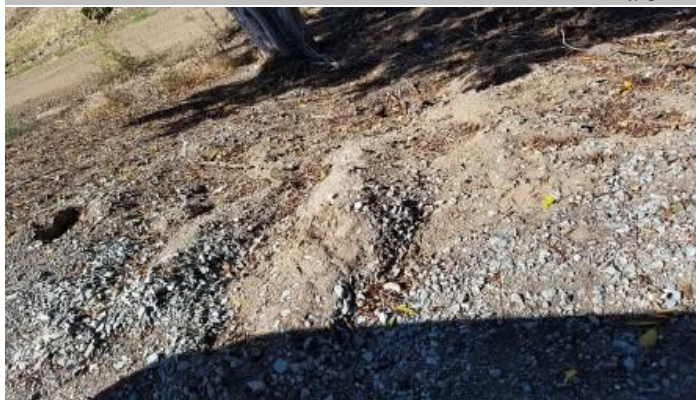
Photo 1 of 1 : SP_2019_RD2064_314_28_20190313_00005.jpg

View of slope damage from vehicular traffic. Fall 2018

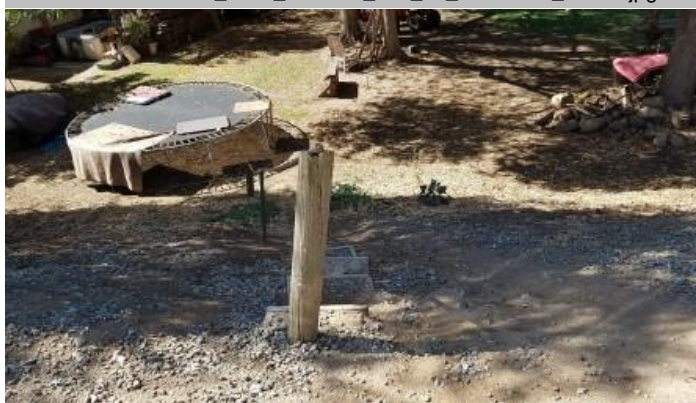
Photo 1 of 1 : SP_2019_RD2064_314_31_20190313_00006.jpg

View of stairway with railing that appears to be without a permit. Fall 2018

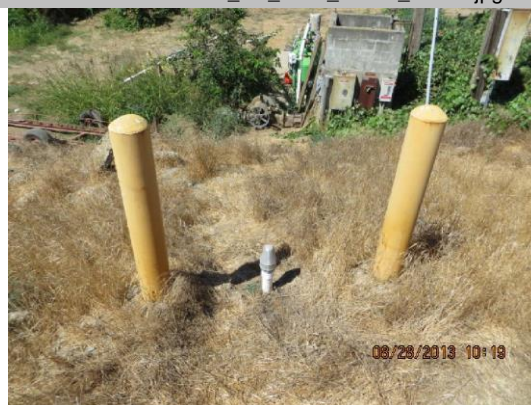
Photo 2 of 3 : UCIP_SP_2019_22095_37721.jpg

Vent on LS shoulder.

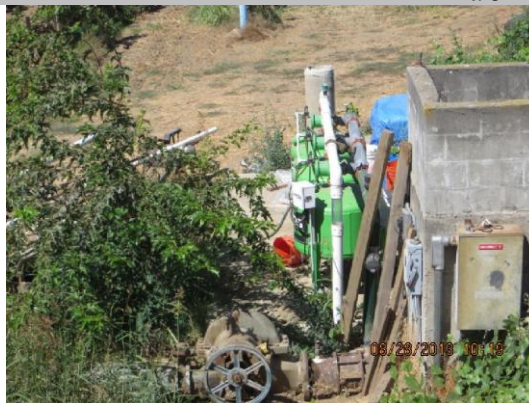
Photo 3 of 3 : UCIP_SP_2019_22095_37720.jpg

Filterplant visible on LS toe.

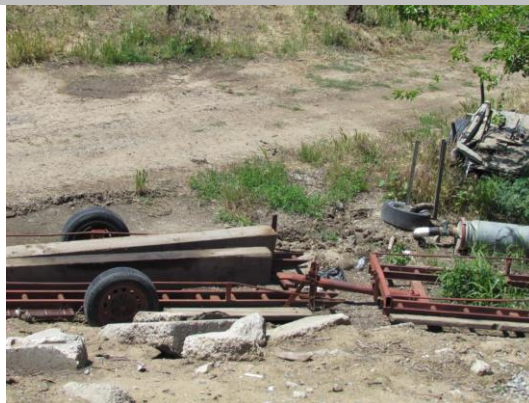
Photo 1 of 2 : SP_2019_RD2064_314_23_20190313_00003.jpg

RD 2064 Landside looking upstream from levee mile 1.97 equipment on the berm.

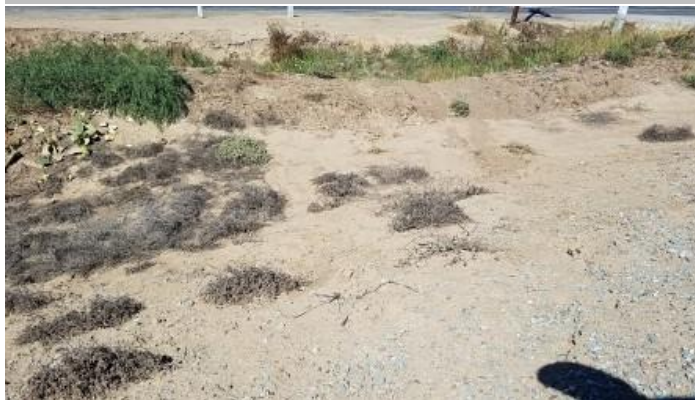
Photo 1 of 1 : SP_2019_RD2064_314_33_20190313_00007.jpg

View of slope damage near ditch caused by vehicular traffic. Fall 2018

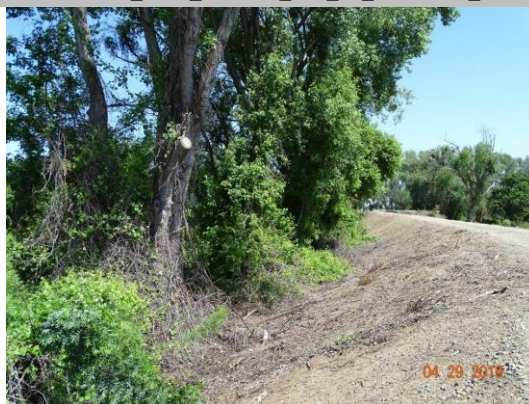
Photo 1 of 1 : SP_2019_RD2064_314_34_20190514_00054.jpg

View of fence with ivy obstructing the visibility of the landside toe.
(Spring 2019)

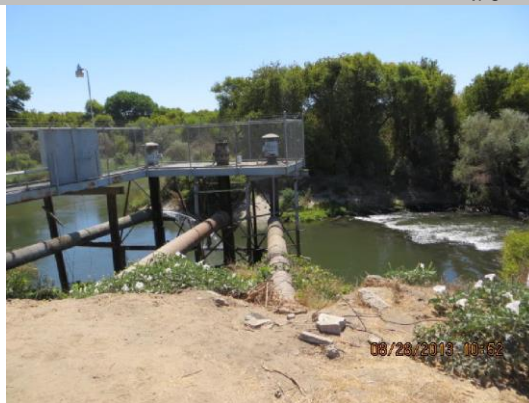
Photo 1 of 3 : UCIP_SP_2019_41075_31963.jpg

Pipe and pump visible on WS berm.

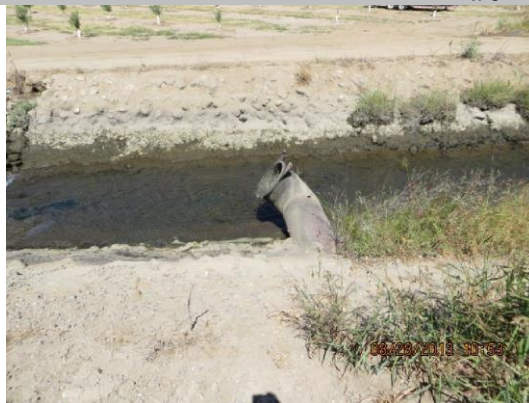
Photo 3 of 3 : UCIP_SP_2019_41075_31961.jpg

Pipe with missing flapgate on LS at concrete ditch.

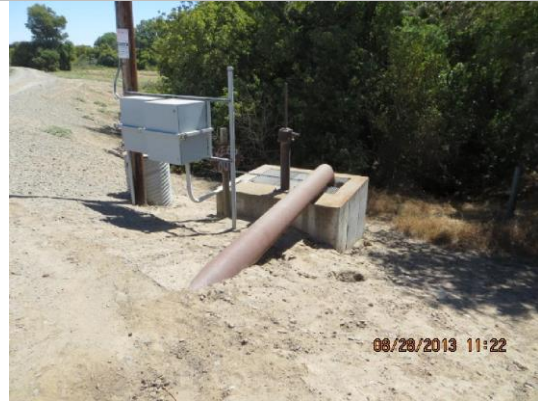
Photo 2 of 2 : UCIP_SP_2019_22107_37735.jpg

Pipe discharges into concrete riser on WS slope.

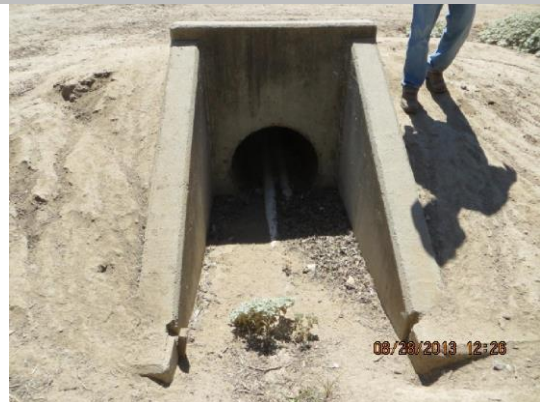
Photo 1 of 3 : UCIP_SP_2019_22108_37739.jpg

PVC pipe at right inside stormdrain on LS toe.

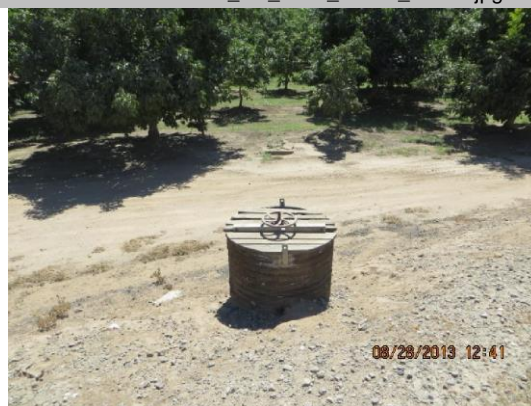
Photo 1 of 2 : UCIP_SP_2019_19145_32126.jpg

Slide gate in CMP riser on WS slope

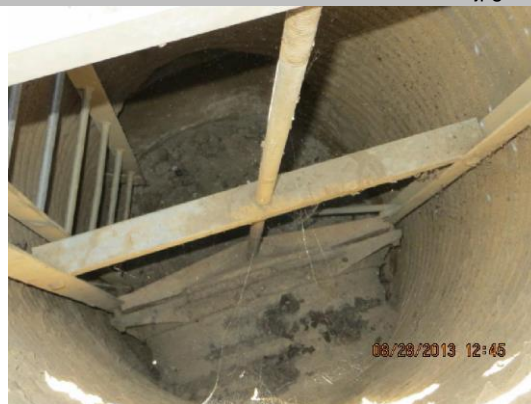
Photo 2 of 2 : UCIP_SP_2019_19145_32125.jpg

Pipe in CMP riser on WS slope.
